SOIL EVALUATION SERVICES INC.

Re: Soil borings in and around existing church.

Site and Soil Evaluation Report

Title	Soil Boring Locations		
Reference Subtitle	Historic Christ Church, Lancaster Co., VA Specific Site Layout		
Drawn By	DRM	Approved By	DRM
Date	3/5/2018	Scale	1" = 50'
Revision	0	Drawing No.

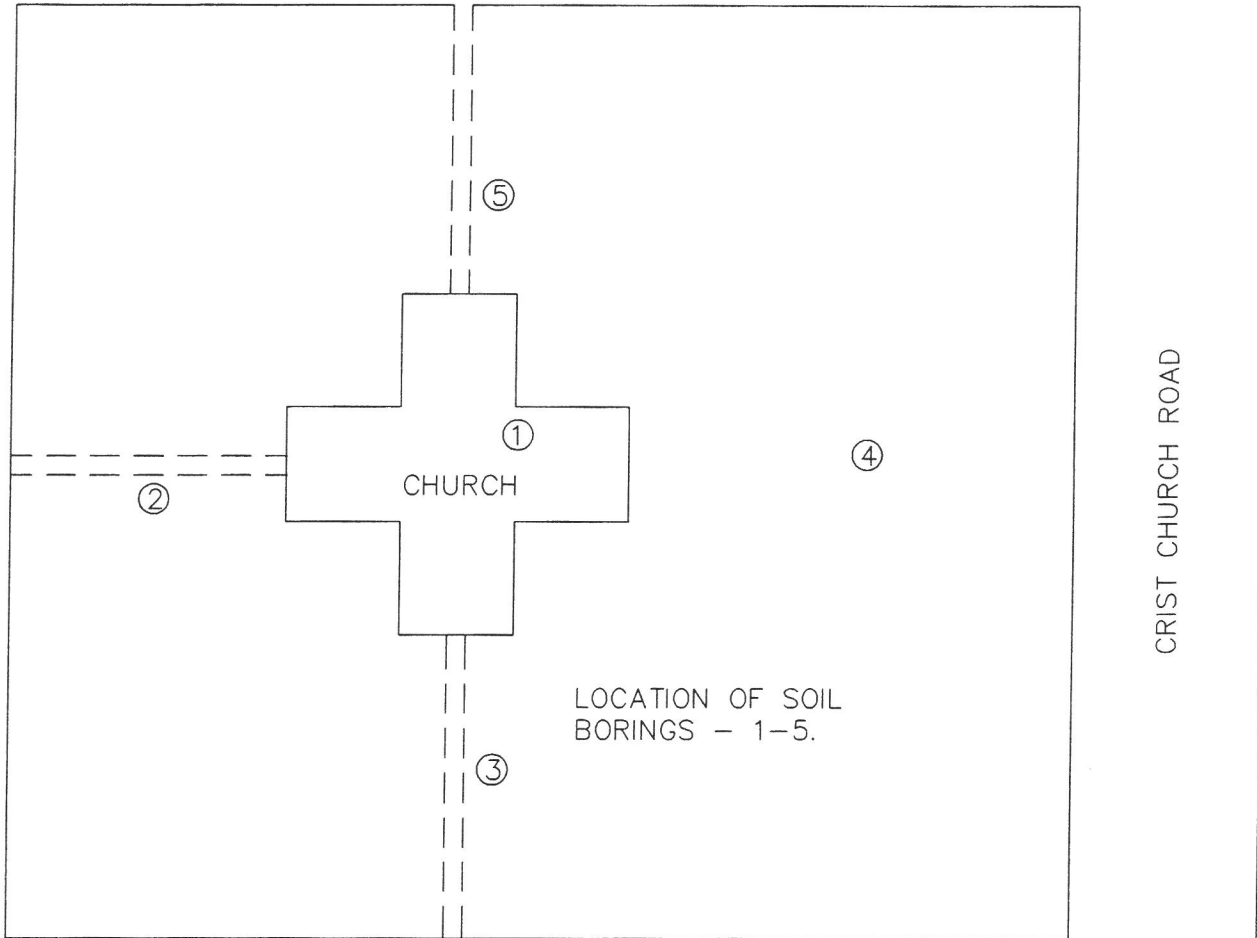
Soil Evaluation Services, Inc. is pleased to present findings regarding the soil conditions for the existing Christ Church. The attached sketch shows the location of the five soil borings. Although the borings vary from each other to some degree, it is believed that the soil morphology is consistent (in all borings) with a Craven silt loam. Depth to perched water table was 12-30"+, with restrictive to impermeable Silty clay loam to Silt Clay to Clay from 24"+. The soils were Massive in Boring #4 from 42-72"+ & Boring #3 from 68-72"+.

The existing brick foundation for the church extends to a depth of approximately 60". Boring #1, (placed inside the church), showed significant wetness in close proximity to the foundation. This appears to confirm the concern that the rain water runoff is migrating down the sides of the foundation, potentially to the depth of the footers, with nowhere to basically drain. This may be causing the water to wick upward, through the brick walls, causing degradation of the mortar. It is important to note that all four borings outside of the church were not significantly wet and no Free Water was observed to a depth of 120" (See boring #2). During the 2 1/2" hour evaluation, Boring #2 remained dry.

BORINGS #2 & #3 PLACED 30' OFF OF BUILDING. BORING #4 PLACED 50' OFF CHURCH. BORING #5 PLACED 22' OFF BUILDING.

The potential corrective measure is to divert the water completely away from the church. However, this will be no easy feat given that the walls extend to 60". It will be quite the endeavor to excavate to a depth of 60"+ around the entire perimeter of the church, install french drains with outfall to the woods, hundreds of feet away. Installation of gutters to tie into this drainage system would also be recommended. The thought process, now that two evaluations have been performed, is to concentrate on promoting drainage away from the church, attempting to drain the water with shallow placed diversion trenches, collecting the water and pumping to the outskirts of the property ultimately into the ravine(s).

A Structural Engineer should be consulted to gain greater insight and perspective to this situation. Hopefully, my two reports will be helpful to the cause. If there are any questions, please contact me.
